**DEPARTMENT OF TRANSPORTATION**

Contract #: 04-0120F4Cty: SF/ALA Rte: 80 PM: 13.2/13.9File #: 99.28**WELDING INSPECTION REPORT****Resident Engineer:** Siegenthaler, Peter**Address:** 333 Burma Road**City:** Oakland, CA 94607**Report No:** WIR-020266**Date Inspected:** 28-Jan-2011**Project Name:** SAS Superstructure**OSM Arrival Time:** 700**Prime Contractor:** American Bridge/Fluor Enterprises, a JV**OSM Departure Time:** 1900**Contractor:** Zhenhua Port Machinery Company, Ltd (ZPMC)**Location:** Shanghai, China

Orthotropic Box Girder (OBG) at Trial Assembly Areas

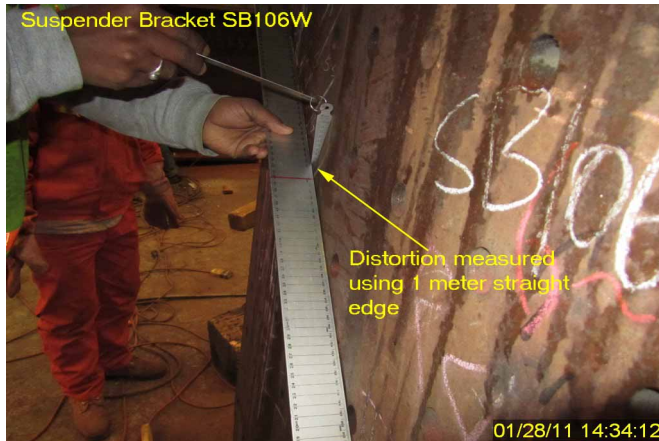
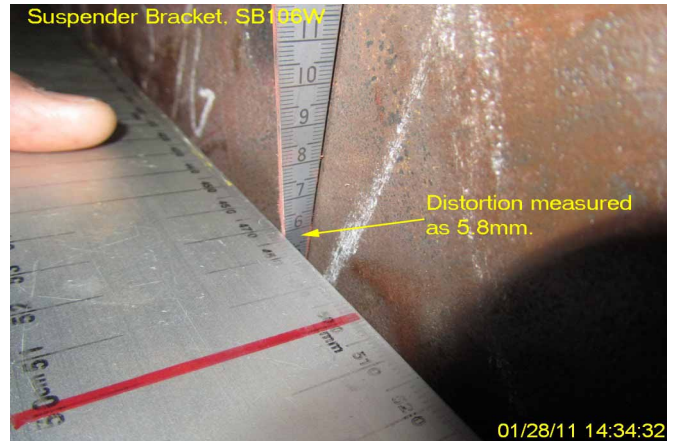
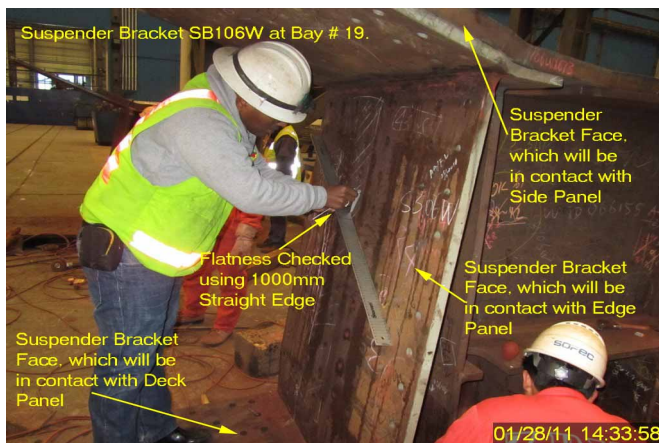
This Quality Assurance (QA) Inspector measured the flatness across the Suspender Bracket Face which will come in contact with Edge Panel. Inspection was performed at the pre-installation stage. The result of Inspection was informed to ZPMC CWI Mr. Shaji and QA Mr. Zhang Wei. Inspection was performed at Bay # 19.

Please reference the pictures attached for more comprehensive details.
